Subject: Antelope Reservoir Sedimentation Survey

ANTELOPE RESERVOIR
SEDIMENTATION SURVEY

DEPARTMENT OF WATER RESOURCES
Northern District

March 1990

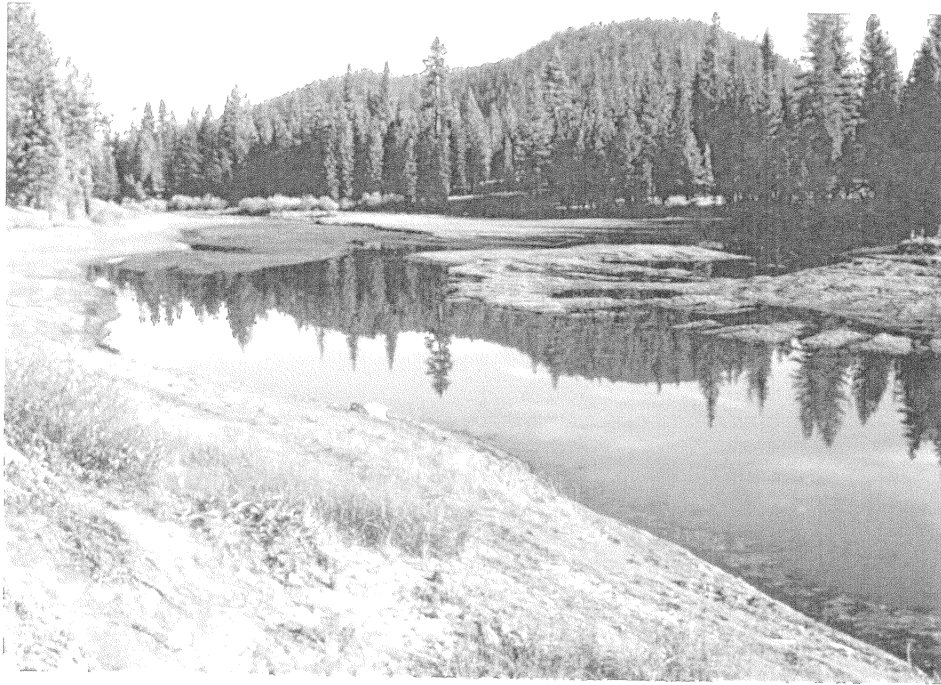
Photo 1: This photo shows sediment infilling the stream channel near Lone Rock Creek campground September, 1989 with the water elevation at 4996 feet.

Photo 3 shows the upper end of Lone Rock Creek where it enters the reservoir. The water surface elevation in this 1989 photograph is 4,998 feet. The channel area and part of the grass are covered by water when the reservoir is at its maximum pool elevation of 5,002 feet. Vertical photographs taken in 1976 by DWR show that the main channel along the thalweg was filled with sediment by 1976. Sedimentation since then has completely filled the active channel and deposited material on the bank areas that flank the channel. Indian and Boulder Creeks show similar infilling adjacent to the Boulder Creek Campground facilities.

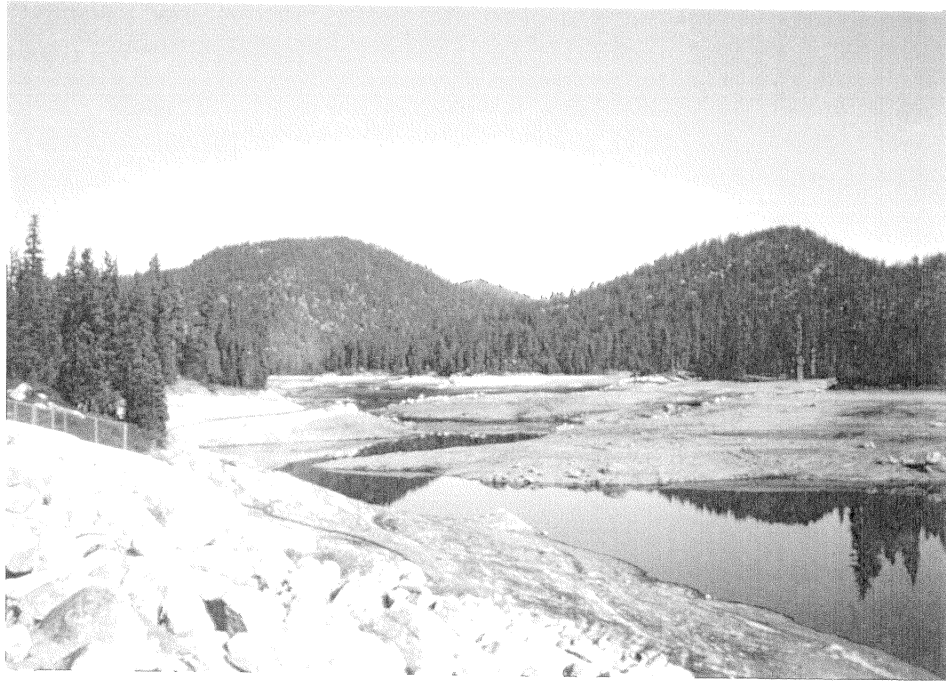
Photo 2: Northern arm of Reservoir in 1977 showing clean side slopes near Dedication Island and channel sediments upstream near the mouth of Indian Creek.

Lone Rock, Indian, and Boulder Creeks enter the northern arm of the reservoir northwest of Dedication Island. Photo 2 shows the northern arm in 1977 with the reservoir water surface elevation at 4,955 feet (Dedication Island is on the right edge of the photo). The reservoir side slopes are clean, lacking any indication of sediment deposition above 4,955 feet elevation. The dark-colored sediments in the background of the photo are delta deposits near the mouth of Indian Creek.

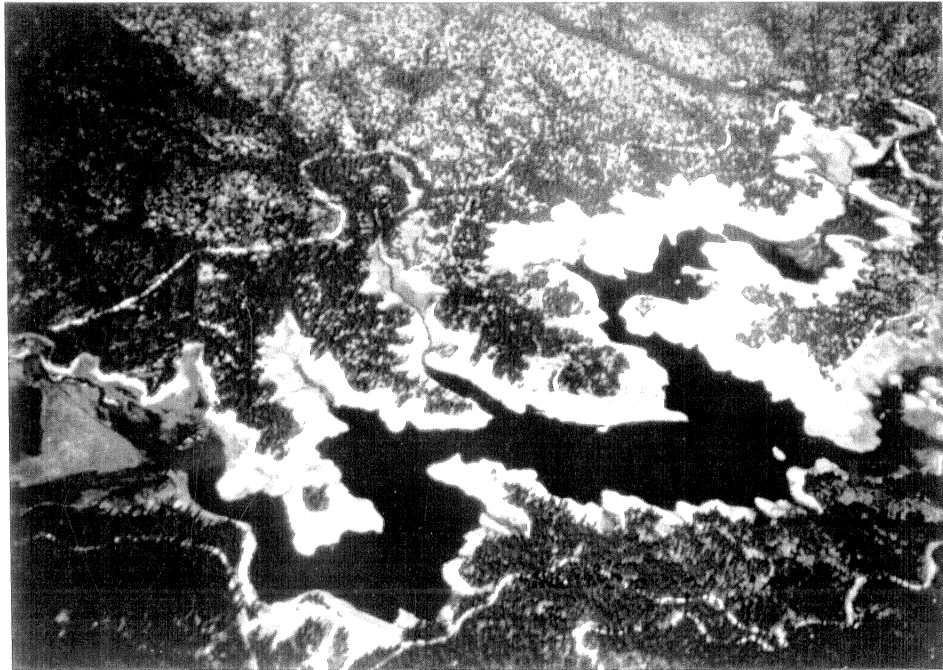
Photo 4: Aerial view of Antelope Reservoir, 1977. Note the delta in the upper right corner of the photo at the mouth of Antelope Creek.

Photo 4 is a 1977 aerial oblique view² of the reservoir with the reservoir elevation near 4,970 feet during the 1976-77 drought. There is a delta at the mouth of Antelope Creek (upper right corner-Photo 4) in the area where range lines A1 & A2 indicate an average 1.5 feet of deposition.

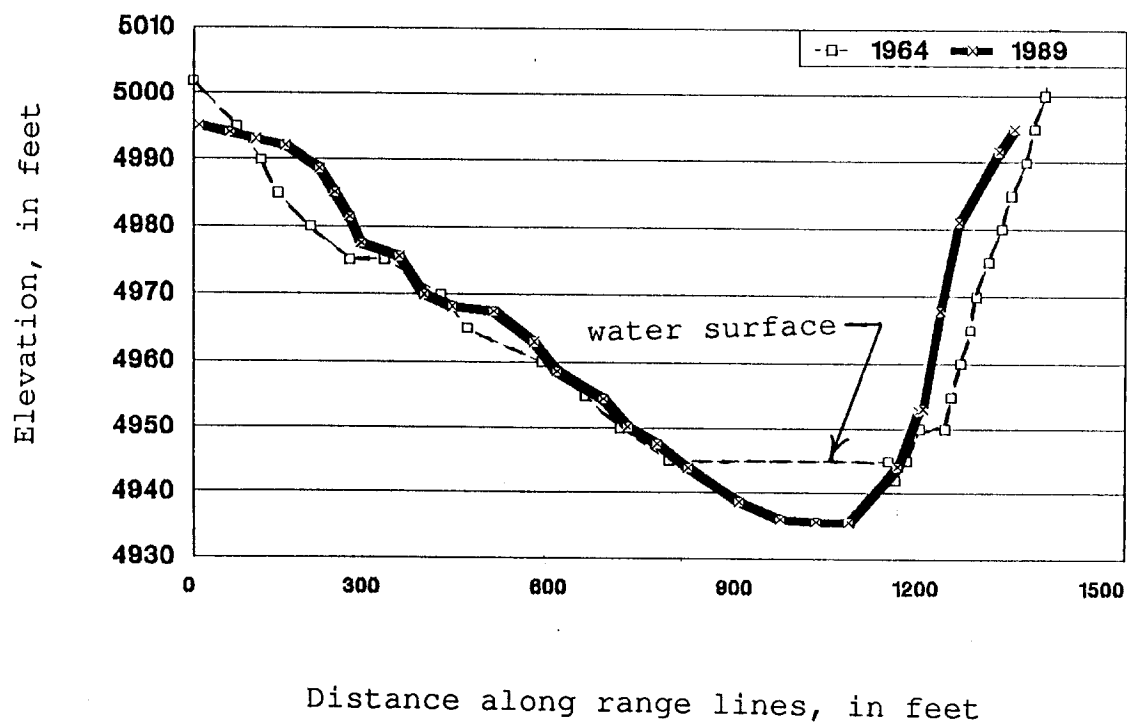
Figure B5

A11-LINE
Northwest----->Southeast

A12-LINE
North----->South

Three range lines near the dam, A11, A12, and A13 (see Appendix B) show 1989 thalweg elevations that are lower than the 1964 elevations. These resulted either from poor topographic control on the original channel survey or from construction modifications that are not recorded on the 1964 topographic map. The map did not have contours below the 4,945 feet elevation in this area. The vertical accuracy of the range line survey in the southern arm is probably +/- 1 foot.
